NAVAL POSTGRADUATE SCHOOL
Monterey, California

THESIS

THE EFFECTS OF JET EXHAUST BLAST IMPINGEMENTS
ON GRAPHITE-EPOXY COMPOSITES

June 1981

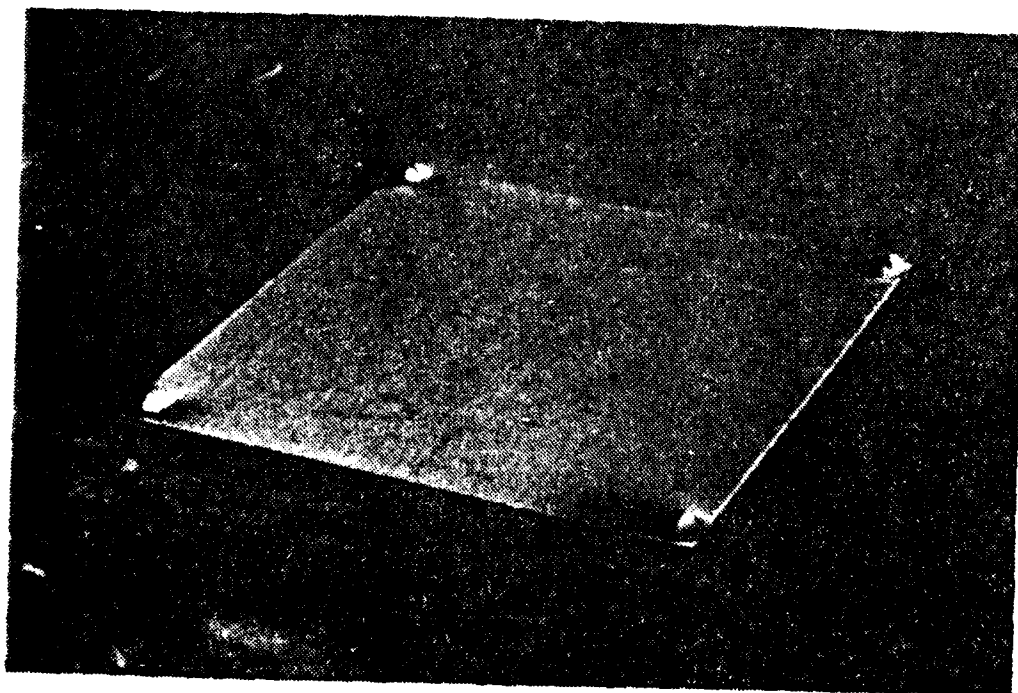
FIGURE 12:   COMPOSITE AFTER JET BLAST TEST.   NOTE CARBON
BUILDUP

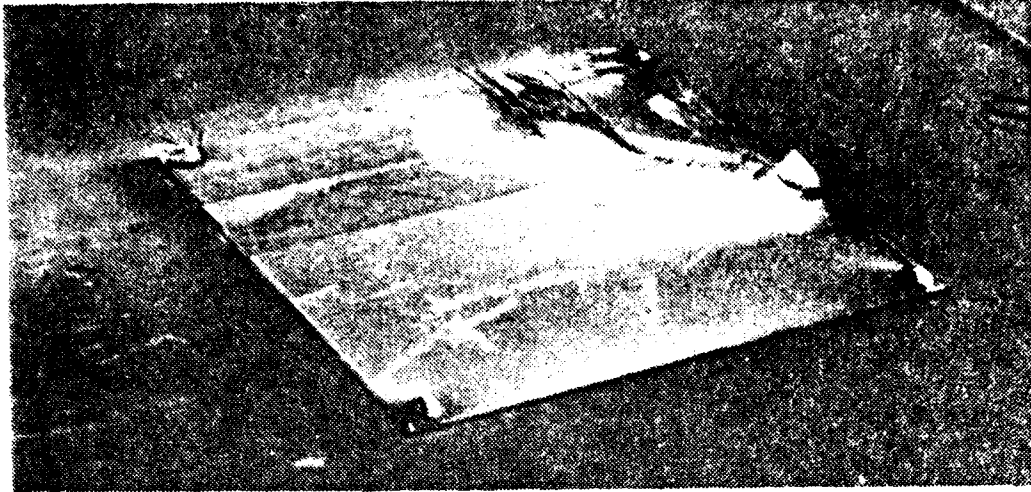
The 1/8 inch sample and the 1/2 inch samples showed conflicting results, the former decreasing in strength, the latter increasing. The 1/8 inch was 93% of the original value vice 112% of the original value of the 1/2 inch sample. The 1/8 inch sample is not considered significant as it is within one standard deviation. The 1/2 inch sample is significant for two reasons: 1) the strength increase is outside the one standard deviation (almost two standard deviations); 2) the result seems to contradict the result of Test 6, which showed a considerable decrease in strength.

FIGURE 19: 1/2 COMPOSITE AFTER TESTING. NOTE DELAMINATION
TEST NUMBER 6

The one possible explanation for the contradiction
is that the temperature in Test 6 far exceeded the recorded
value of 230°C, as the temperature in this test was 230°C.
It was noted that the temperature in Test 6 was far in excess
of that recorded and this also seems to verify that belief.

The 1/2 inch specimens had two results outside the range of ± 6% of the original strength (Test 6 and Test 7). The shear strengths from Test 6 was significantly lower than the original strength, with only 57% of the untested sample strengths. The temperatures from this test are inaccurate due to thermocouple failure. It is only known for certain that the temperature exceeded 220°C. The thermocouple failed at that temperature and the composite remained in the blast for about another 45 seconds. The temperatures were still increasing at thermocouple failure so it is certain the temperature exceeded the recorded value of 220°C. This is further verified by the fact that the thermocouple wires had fused together and the insulation on the thermocouples was rated for 370°C. It is unlikely that the temperatures reached that value due to the short duration of exposure after thermocouple failure, but the temperatures were undeniably in excess of 220°C. This sample also showed visible signs of delamination (Figure 19). Test 7 reached a maximum temperature of 230°C. Test 7 sample however, showed an increase in strength to 112% of the original strength. Six of the nine jet blast tests exceeded the 200°C limit, two as discussed above, and of the other four tests, two were slightly above the original strength and two slightly below but all results were within a ± 5% range.

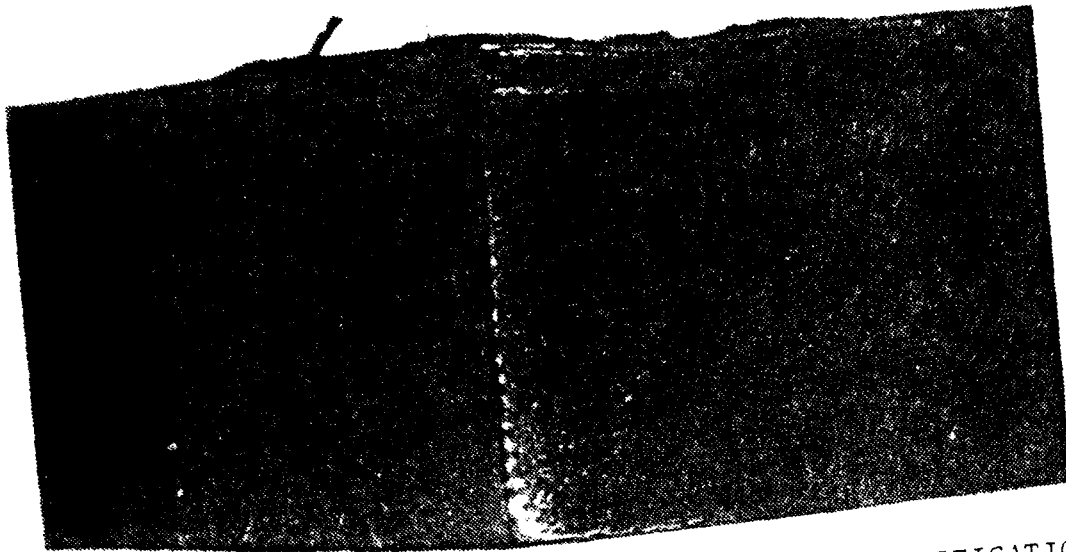
The 1/4 inch sample showed slight delamination of the composite in a very small area in one dorner (Figure 21). The results of the shear test for the 1/4 inch sample indicates that small areas of delamination do not imply a degradation of the entire composite.

FIGURE 21: 1/4 COMPOSITE AFTER TEST 13 (10X MAGNIFICATION).
NOTE DELAMINATION AT CORNER

FIGURE 22: SAME AS ABOVE (12X MAGNIFICATION)

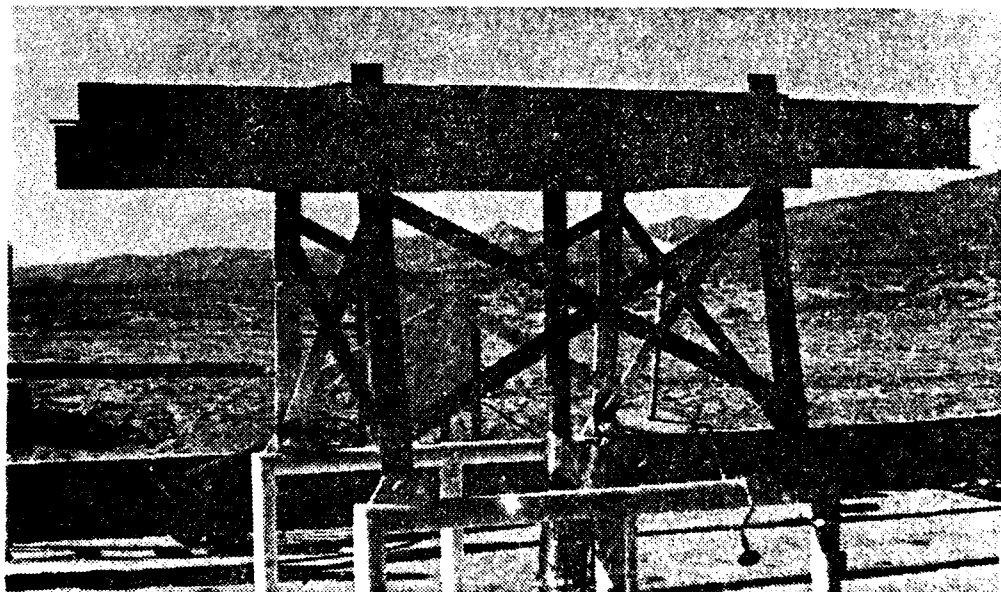
FIGURE 23: WINGBOX AT CONCLUSION OF TESTING. NOTE SOOT BUILD-UP ON WINGBOX
